## REMR TECHNICAL NOTE CS-MR-8.1

### CASE HISTORY OF UNDERWATER CONCRETE REPAIR: REPAIR OF STILLING BASIN, WEBBERS FALLS LOCK AND DAM, ARKANSAS RIVER, USING TREMIE CONCRETE

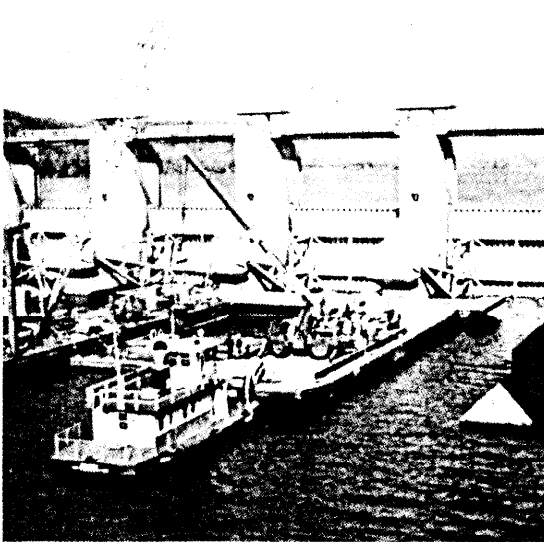
Figure 1. Work area showing equipment arrangement

Several barges lashed together formed a work platform (Figure 1) over the area to be repaired. Prior to placement of the concrete, the damaged area was air-cleaned of silt and debris. The concrete was conveyed to the area by loading the transit-mix trucks on a barge (Figure 2) at a point about half a mile below the dam. Because of the length of time required to get from the batch plant to the work site, the cement and some water were withheld from the mix until the trucks had been loaded on the barge and were approaching the work area.

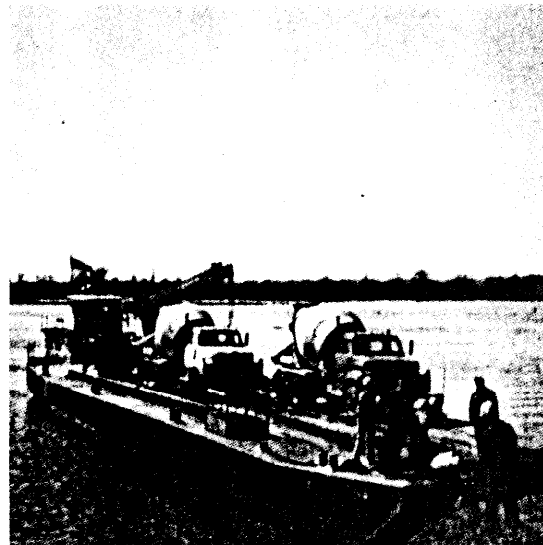
Figure 2. Transit mixers carried to work site by barge

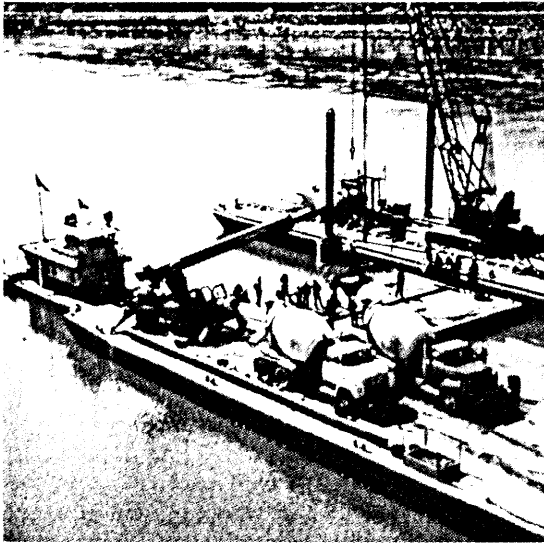
Figure 3. Placement in progress

Placement was made by transferring the concrete from the truck into a 1-cu-yd-capacity bucket (Figure 3). The bucket was positioned by crane over a 1-cu-yd-capacity hopper attached to a 10-in.-ID tremie pipe (Figure 4).

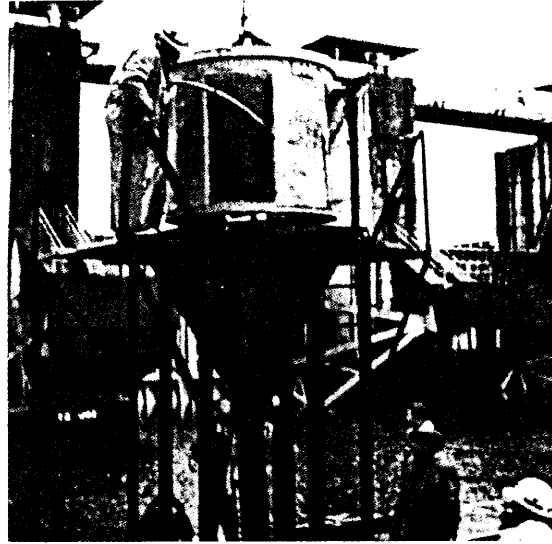
Figure 4. Concrete being discharged into hopper of tremie pipe

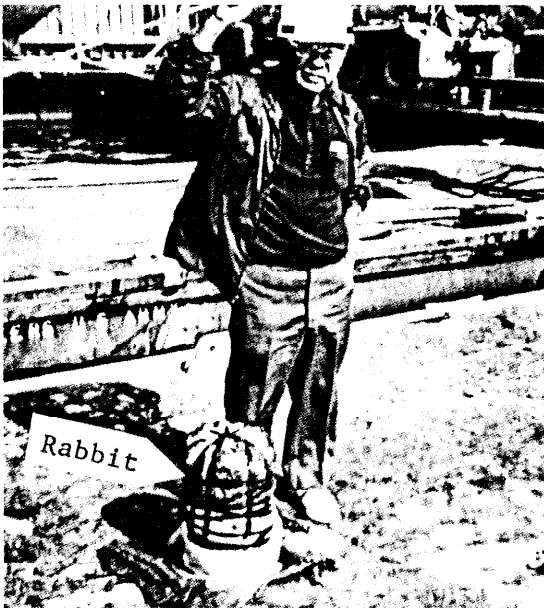
Figure 5. A "rabbit" forced the water out of the tremie pipe ahead of the concrete

A "rabbit," composed of a greased polyethylene bag filled with burlap bags (Figure 5), was placed in the top of the tremie prior to placing the concrete in the hopper. The bottom of the tremie pipe was positioned by divers (Figure 6) and rested on the surface of the existing concrete in the hole. When the fresh concrete forced the rabbit to the bottom of the pipe, the pipe was raised approximately 1 ft to eject the rabbit and permit the flow

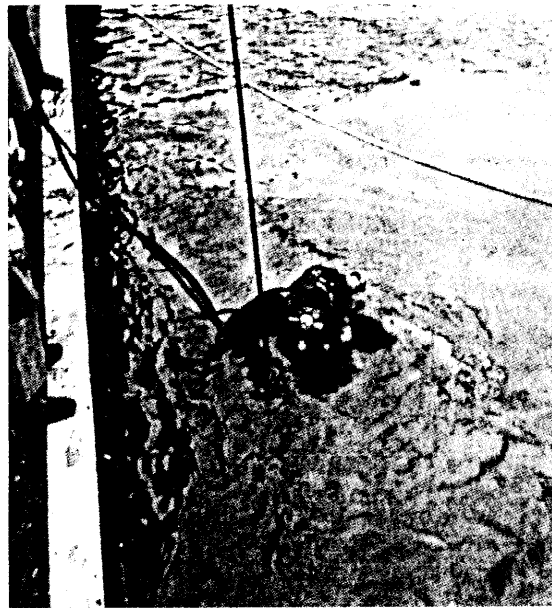
Figure 6. Army divers assisted in the repair work
